## Strip Switch Panic Bar

# J. H. Fletcher & Co.

# Important Safety Notice

Subj.: Retrofit - Pressure setting on RRII/DDO

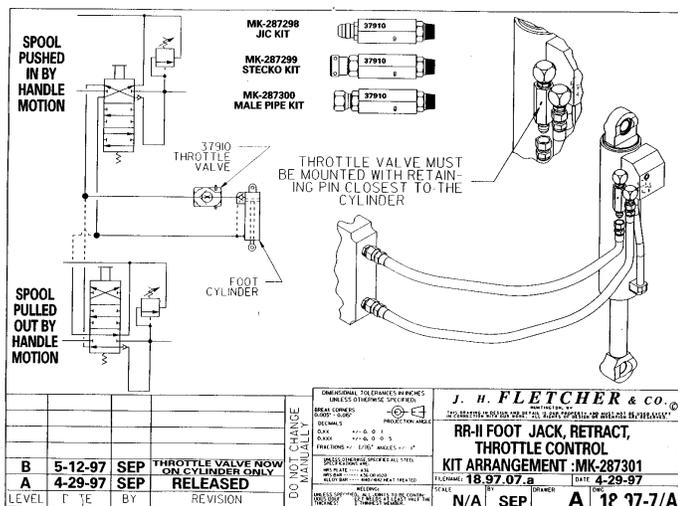
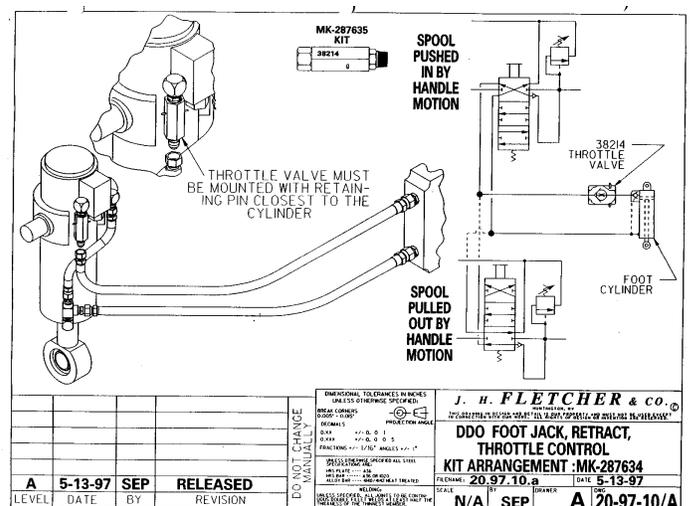
J.H. Fletcher & Co. has been informed of three accidents that occurred on RRII roof bolters when the boom dropped rapidly resulting in the driller's canopy striking the operator on the head, neck or back

The major contributing factor when accidents such as these occur is that the foot jack pressure is set to high, allowing the foot to lift the front end of the machine. When the foot jack is retracted, the boom and canopy may drop rapidly potentially causing the canopy to strike the operator on the head, neck and back.

When investigating these accidents it was found that the pressure in the foot jack circuit had been altered from the 500-700 psi setting specified by Fletcher. The alterations take place when the foot jack control valve is replaced or repaired and the correct relief valve and specified pressure setting are not maintained or the relief valve has been readjusted from the original OEM specified pressure.

To prevent this situation from occurring again J.H. Fletcher & Co. is notifying and recommending specific steps be taken in INFORMATION BULLETIN NO. 67. If you have a RRII/DDO which are the machine that are affected by the retrofit and have still not received this bulletin we request that you call J.H. Fletcher & Co. Risk Management Department today for a complete copy of this bulletin.

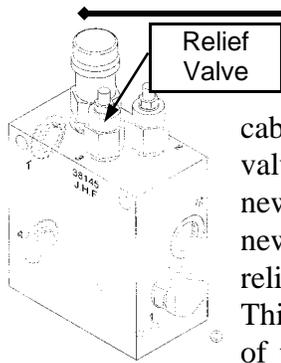
Over the last year J.H. Fletcher & Co. has changed its cable reel valve. The original valve was part number 37811 the new part number is 38145. The new cable reel valve incorporates a relief as a brake in the valve body. This will prevent any backlashing of the cable, while the operator is

using the cable reel function.

If you order the old part number today from our service department you will receive the new part number in a kit (part number 38225). Remember, when you get the new part you will not need the sequence valve in the circuit because it is incorporated into the new valve assembly.

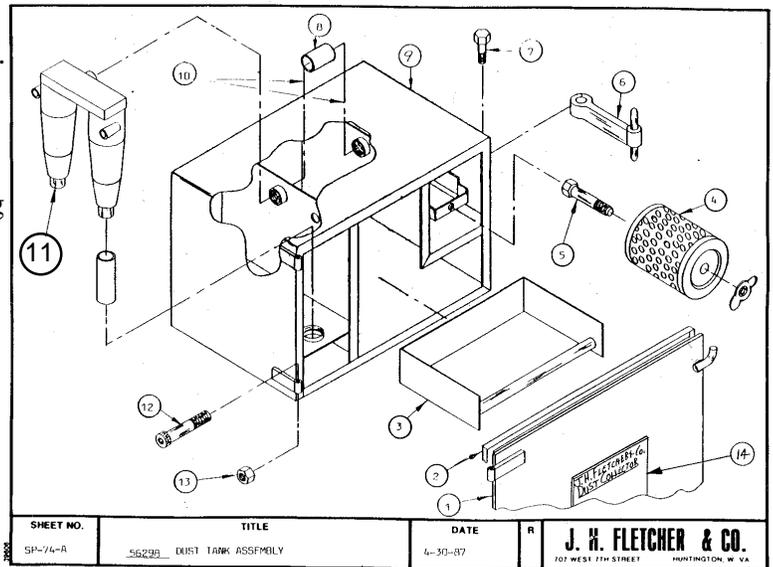
The dust tanks on your Fletcher roof bolting machines are manufactured by J. H. Fletcher & Co. The dust tank assembly drawing is found in your parts book and is labeled as drawing SP-74-A. It has come to our attention that prior to April 1997 the cyclone identified as number 11 on the drawing was incorrectly identified on the parts sheet as part number 56231. The correct part number should be 56272. Please make the appropriate correction in your parts book or call the Parts Book department for the correct parts sheet. We apologize for this error and any problems this may have caused. If you have any questions regarding the dust collection system, please contact Ben Pack at J. H. Fletcher & Co. (304) 525-7811.
