IMPROVING THE CAPABILITY FOR REAL TIME ASSESSMENT OF ROOF CONDITIONS THROUGH INTELLIGENT ROOF BOLT DRILLING OPERATIONS

Robert Anderson, Design Engineer
J. H. Fletcher & Company
Huntington, WV

L. J. Prosser, Research Scientist
NIOSH - Pittsburgh Research Laboratory
Pittsburgh, PA, USA

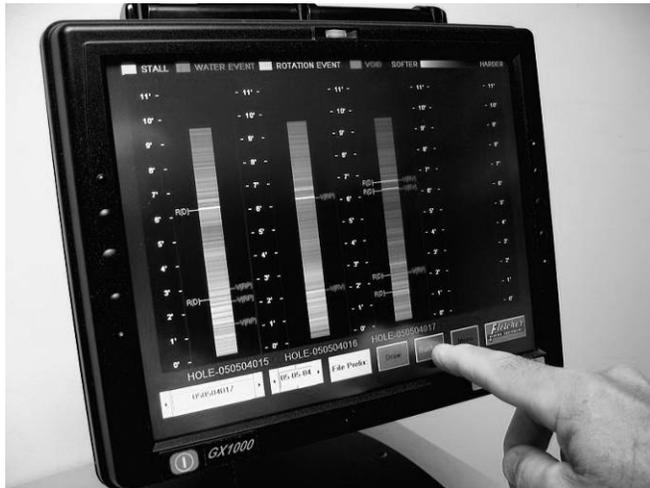
The software was tested in the laboratory and in the mine and was refined to improve its accuracy. In a recent project with West Virginia University (WVU), the software was modified to communicate in real time with the drill control unit and display the information as the holes were being drilled. With this new system, graphs illustrating information from four separate drill holes were displayed side-by-side so that trends could be easily seen. The display and analysis can be activated through a rugged touch screen panel installed on the bolting machine to facilitate use underground by the roof bolter or other mine officials (see figure 2).

Figure 2. FLETCHER® Information Display

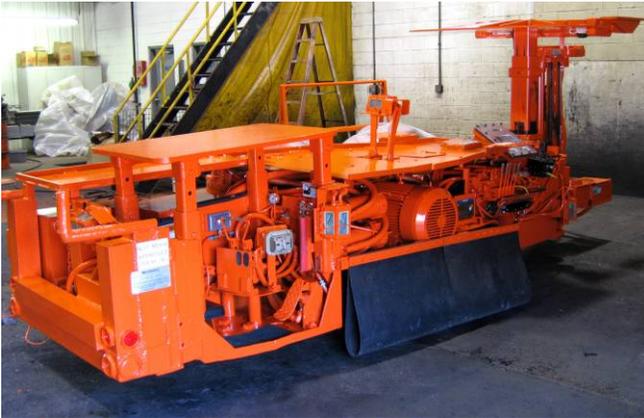
In another joint project with WVU, a test machine was built for use in an underground coal mine. An older single-boom roof bolter was rebuilt with modern components including the latest generation of drill head and drill control unit. The FLETCHER® Information Display was installed in an explosion-proof housing on the machine. Figures 3 and 4 show the coal test machine and the information display.

Figure 3. Roof bolter used for testing in underground coal mine.

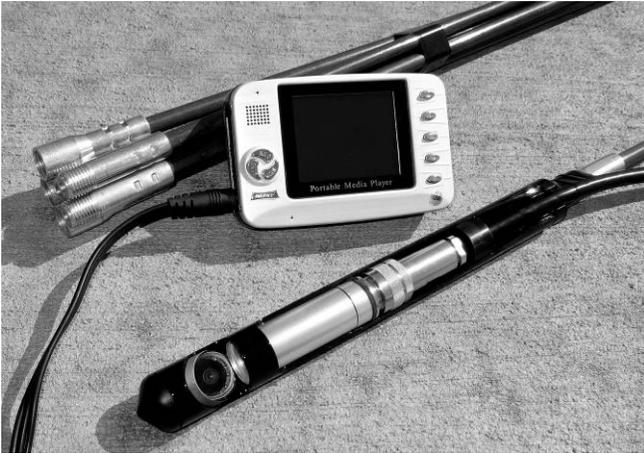
Scoping holes were also analyzed using a small bore scope (less than 1 in diameter) as shown in figure 7. Video files were recorded for each hole. Initially, the bore-scope videos showed few discontinuities in the holes. Only two of the holes had obvious voids (see figure 8). The holes were flushed out with water, assuming that dust from the drilling might be obscuring the voids. The holes were bore-scoped a second time and again there were not clear voids at the locations indicated on the drill data files. A scratch tool was used to feel for soft bands or ledges in the holes. Discontinuities were found in almost every case at or near the locations indicated by the drill data files. Fifteen more holes were drilled in this area during another visit with similar results.

Figure 7. FLETCHER® Bore Scope.

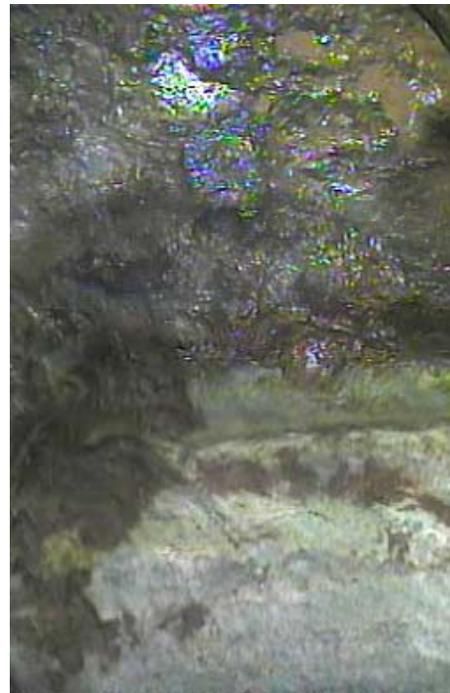
seams near the top of the hole. These were visible in the drill data files as lighter shades of gray. When the software sensitivity was adjusted they were marked as voids. The clay seams were clearly visible in the bore-scope videos. Figures 14 and 15 show the hole graphs and a bore-scope image.

Figure 15. Bore-scope image of clay seam.

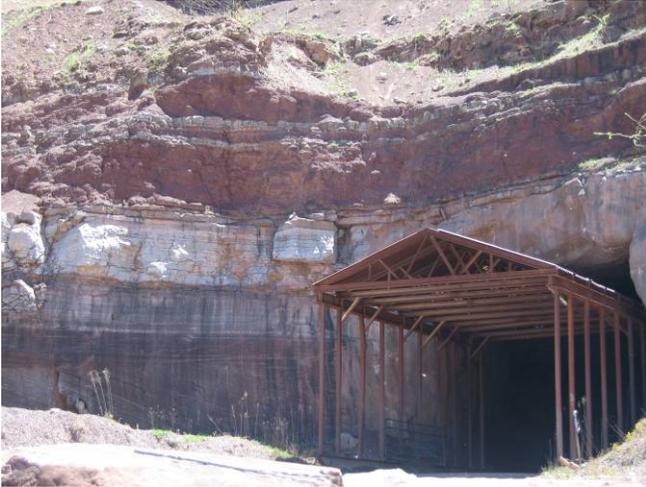
A photo from outside the mine opening shows the red clay above the limestone seam (see figure 16).

Figure 16. Red clay above limestone.
